Site Accessibility Evaluation

IOOF Cemetery Trail

Accessibility Evaluation

Inspection Date: 05/14/2021

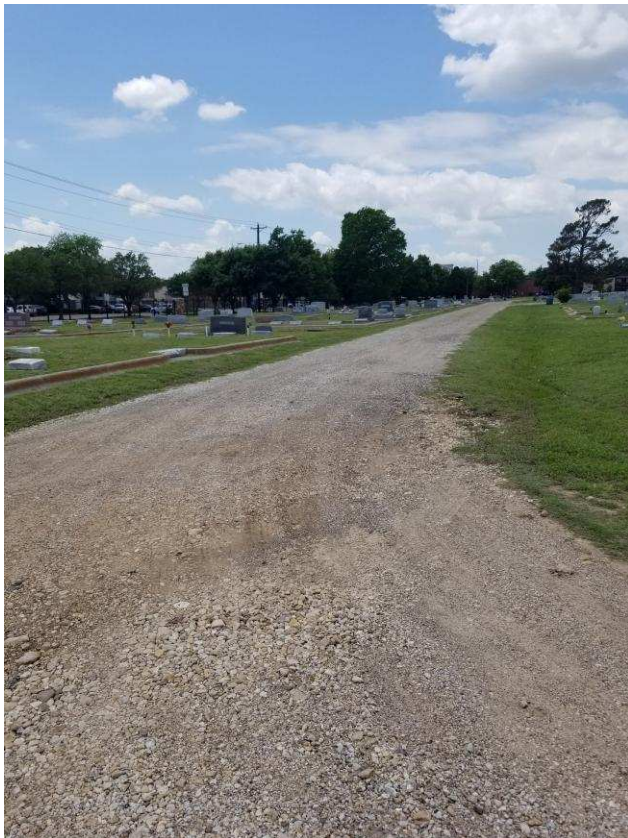
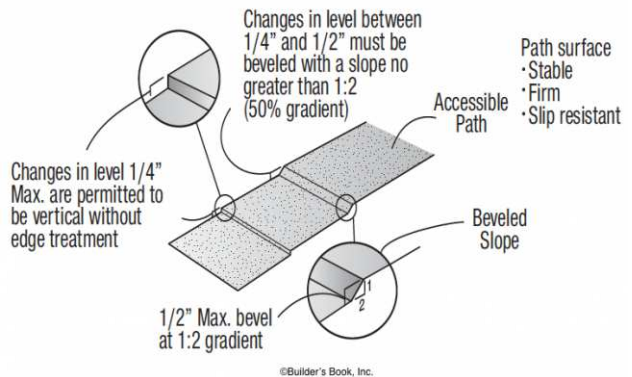
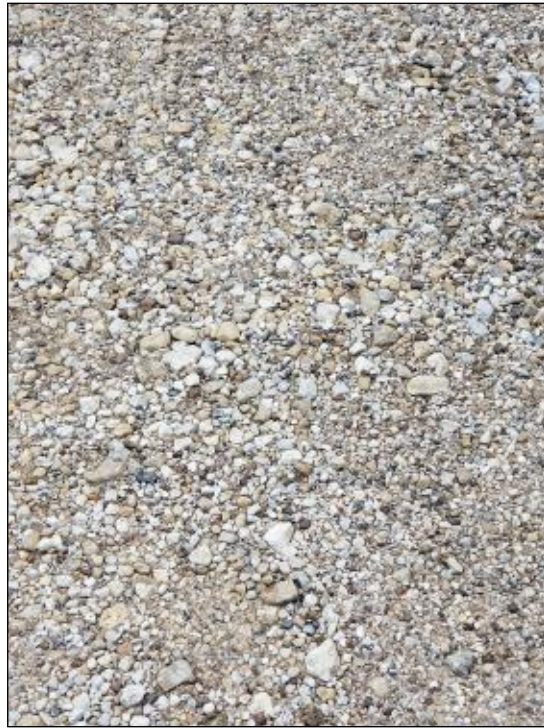
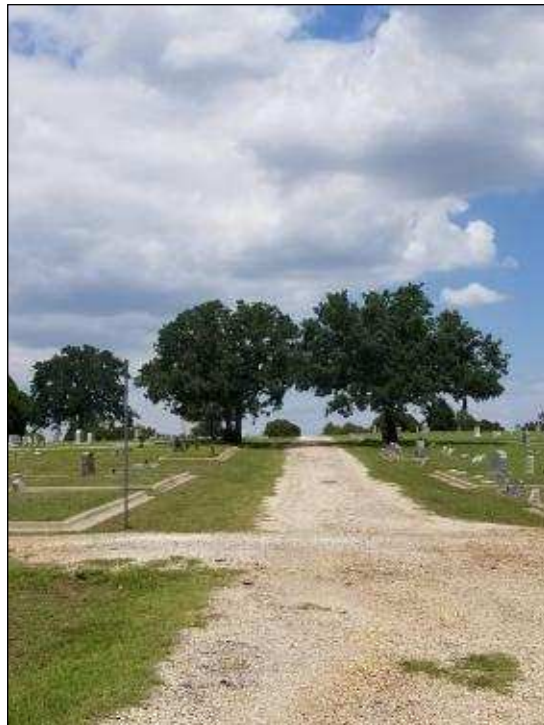
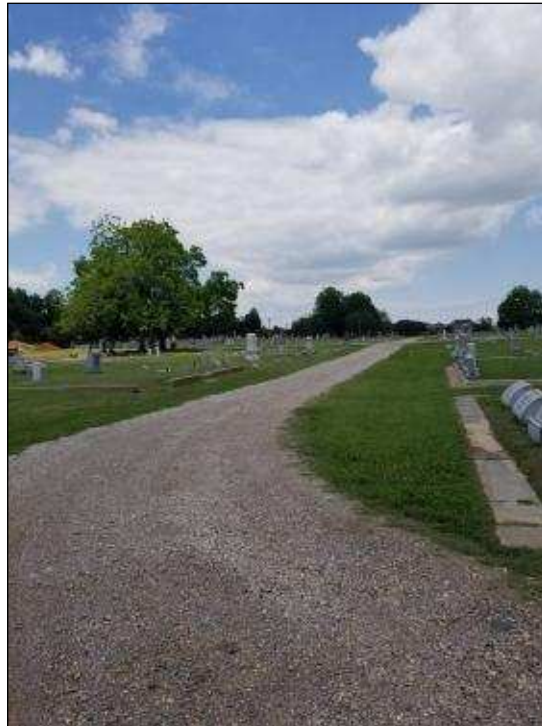
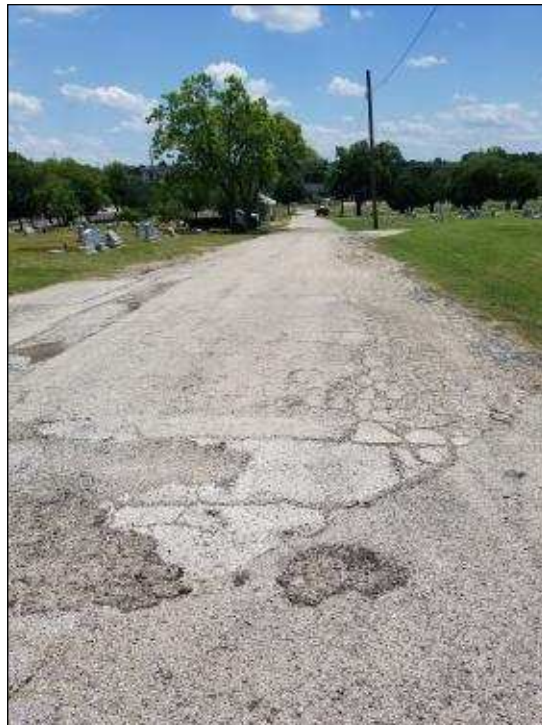
Barrier: 1

2010 ADAS Section: 302.1

The accessible route contains loose gravel that does not provide for a stable, firm, slip-resistant surface.

Level 4 (High): Parking and exterior accessible routes (DOJ Level 1) – moderately out of compliance

Provide a level, stable, slip-resistant ground surface as the path of travel.

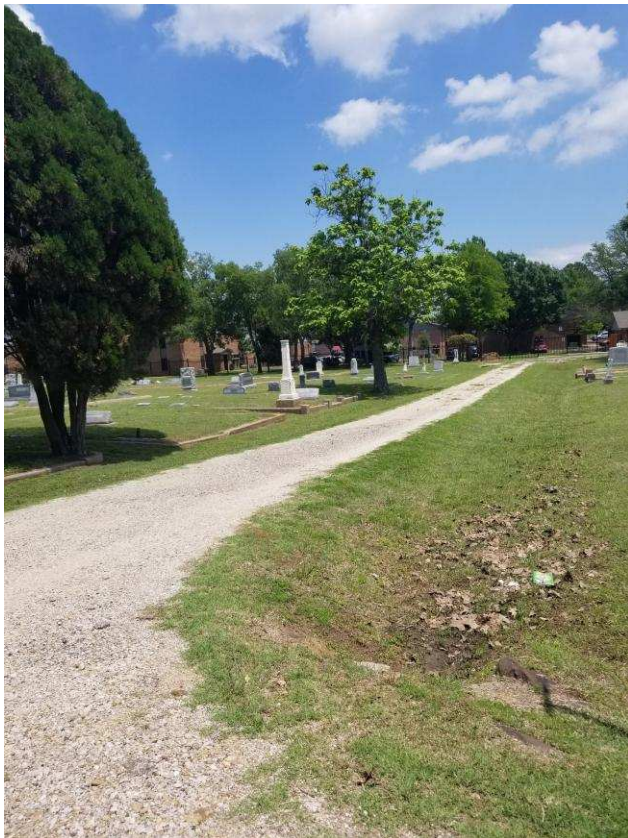
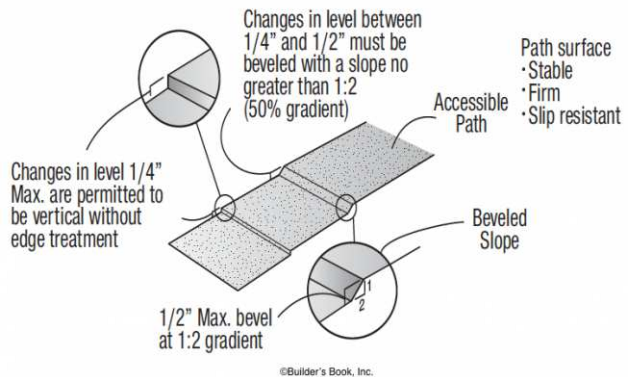
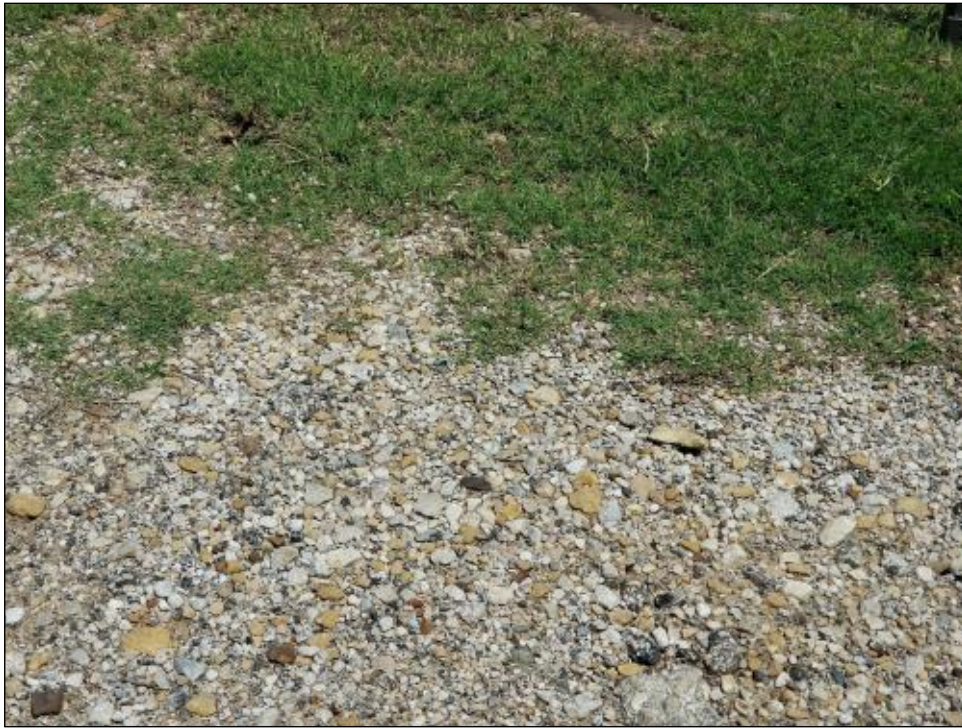
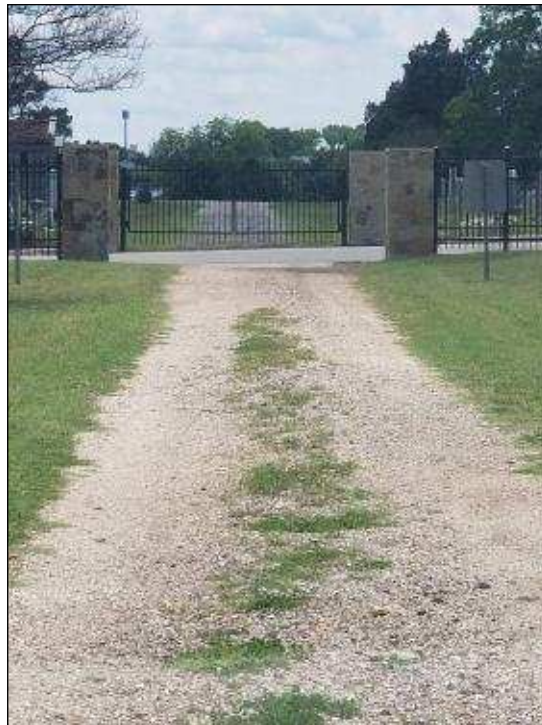
Barrier: 2

2010 ADAS Section: 302.1

The accessible route contains loose gravel that does not provide for a stable, firm, slip-resistant surface.

Level 4 (High): Parking and exterior accessible routes (DOJ Level 1) – moderately out of compliance

Provide a level, stable, slip-resistant ground surface as the path of travel.

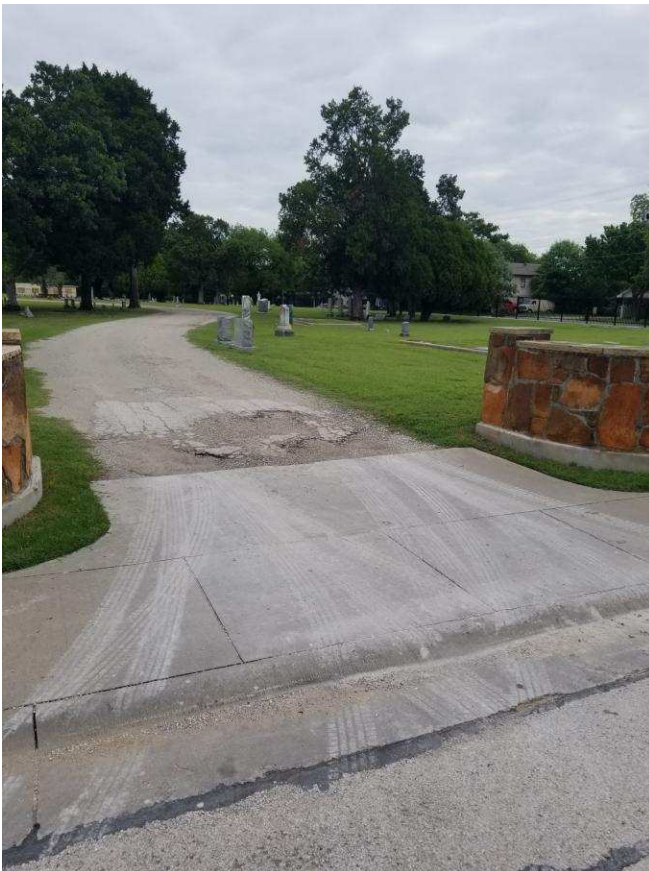
Barrier: 1

2010 ADAS Section: 303.4

The walkway contains changes in level greater than a 1/2 inch high that should be ramped.

Level 4 (High): Parking and exterior accessible routes (DOJ Level 1) – moderately out of compliance

Provide a ramp from the street to the path of travel.

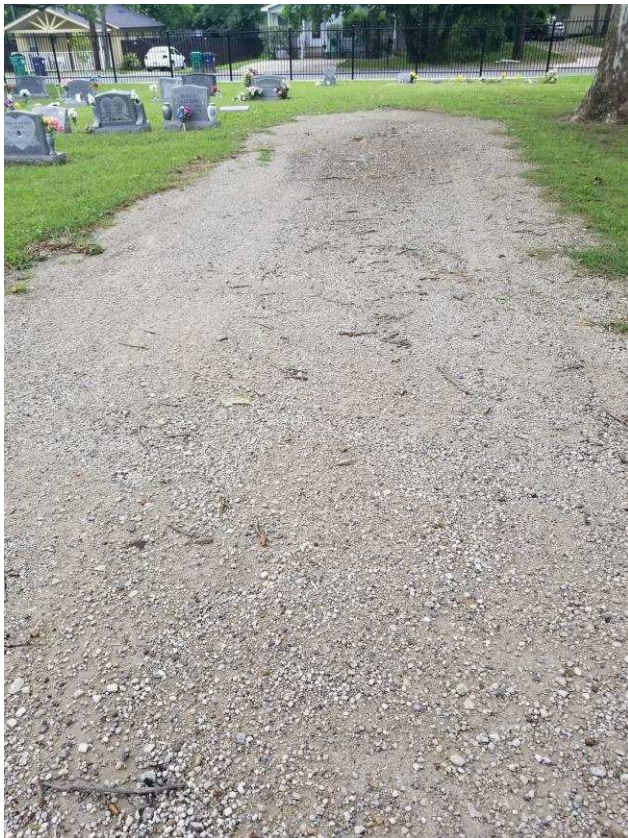
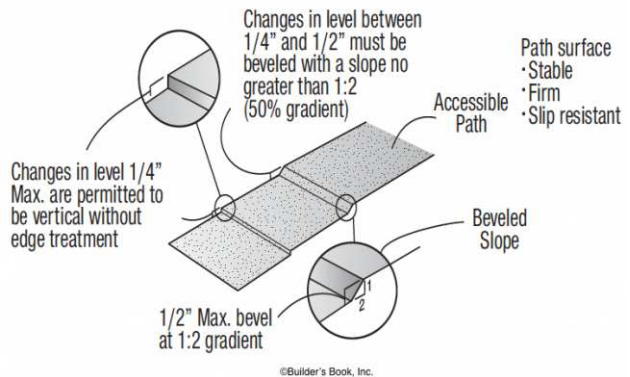
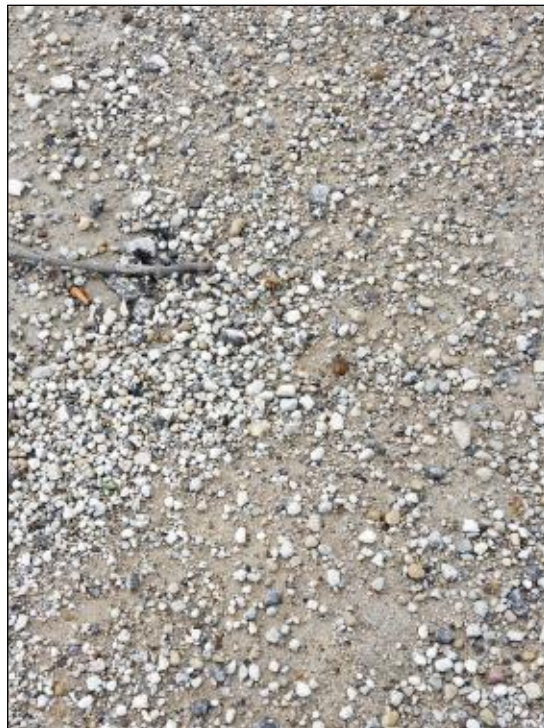
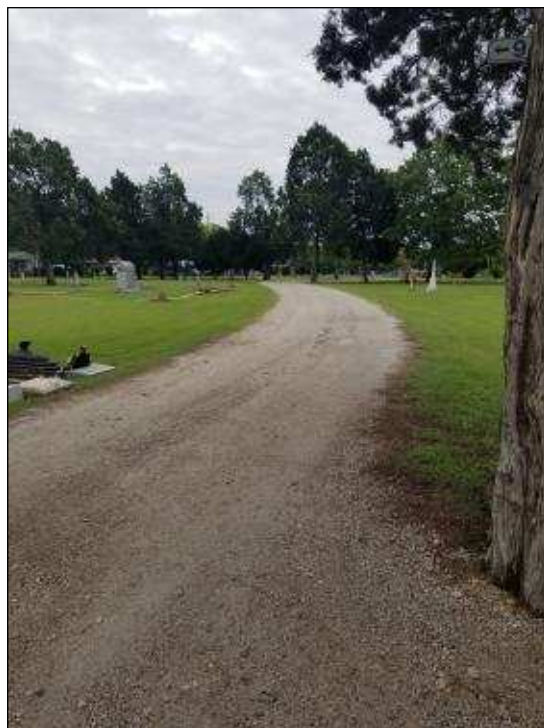
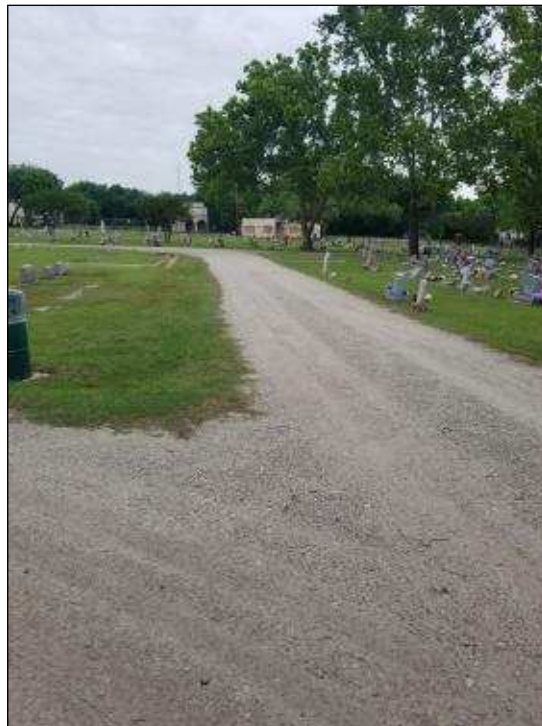
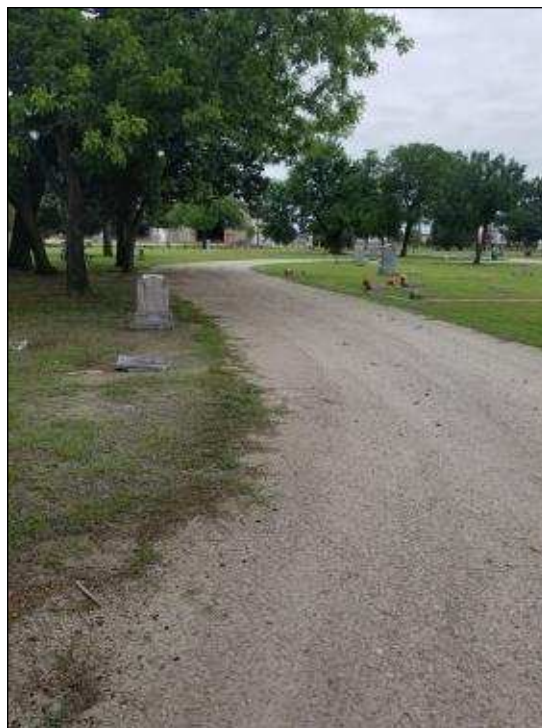
Barrier: 2

2010 ADAS Section: 302.1

The accessible route contains loose gravel that does not provide for a stable, firm, slip-resistant surface.

Level 4 (High): Parking and exterior accessible routes (DOJ Level 1) – moderately out of compliance

Provide a level, stable, slip-resistant ground surface as the path of travel.

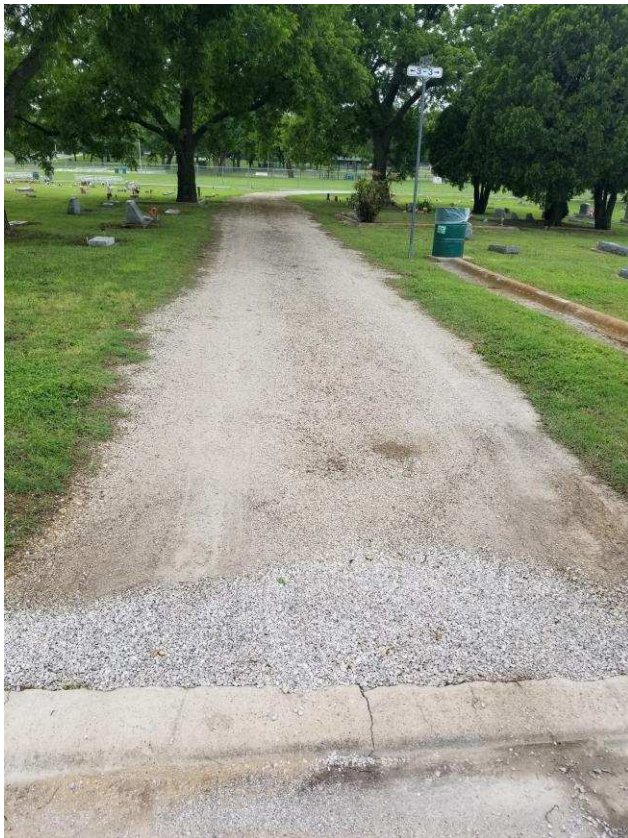
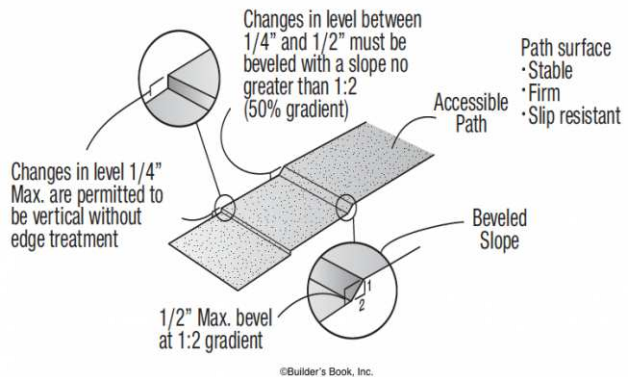
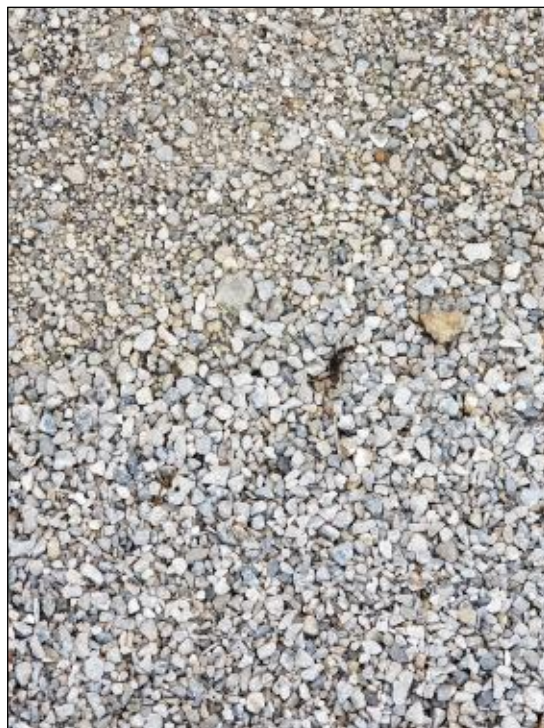
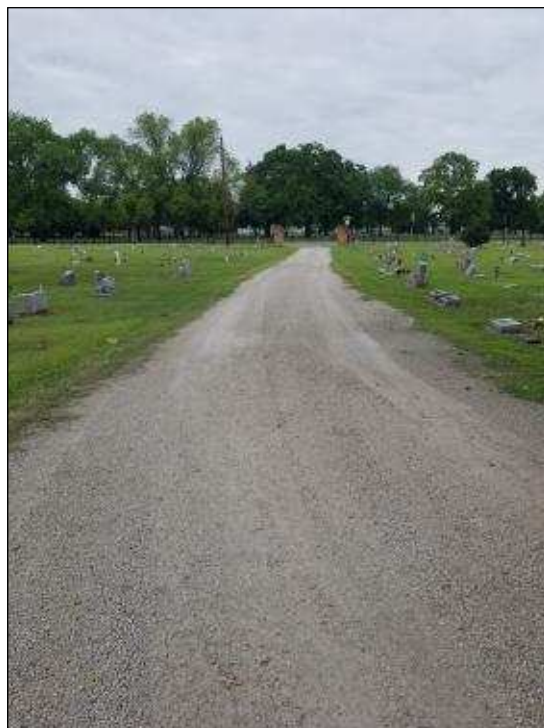
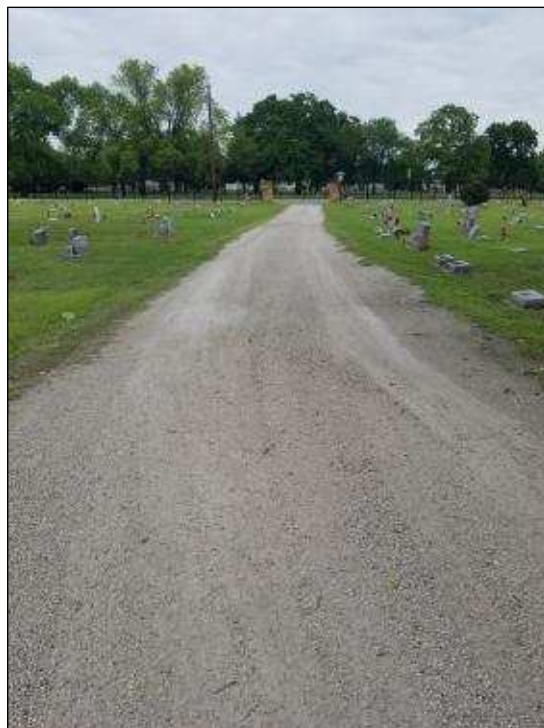
Barrier: 3

2010 ADAS Section: 302.1

The accessible route contains loose gravel that does not provide for a stable, firm, slip-resistant surface.

Level 4 (High): Parking and exterior accessible routes (DOJ Level 1) – moderately out of compliance

Provide a level, stable, slip-resistant ground surface as the path of travel.

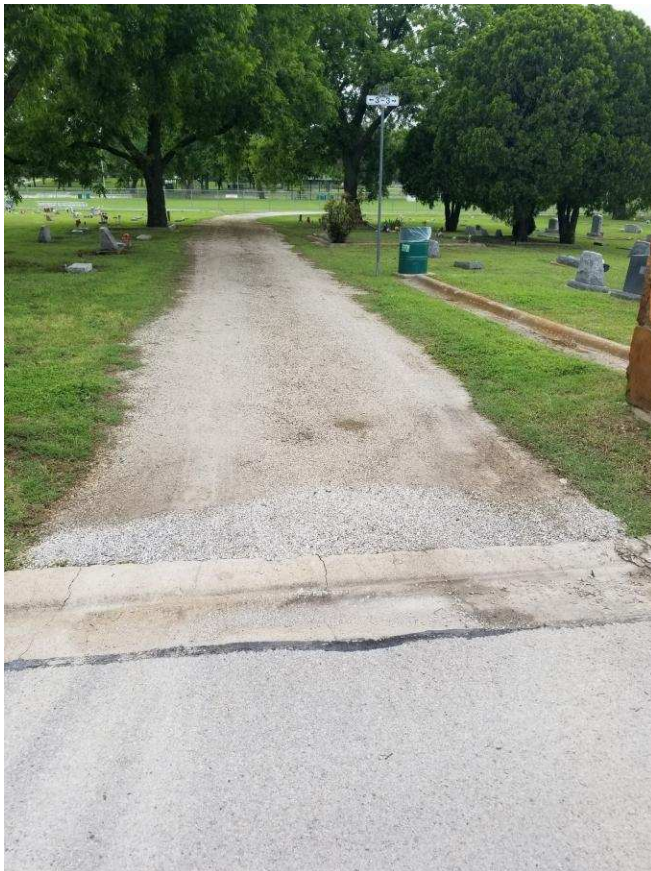
Barrier: 4

2010 ADAS Section: 303.4

The walkway contains changes in level greater than a 1/2 inch high that should be ramped.

Level 4 (High): Parking and exterior accessible routes (DOJ Level 1) – moderately out of compliance

Provide a ramp from the street to the path of travel.

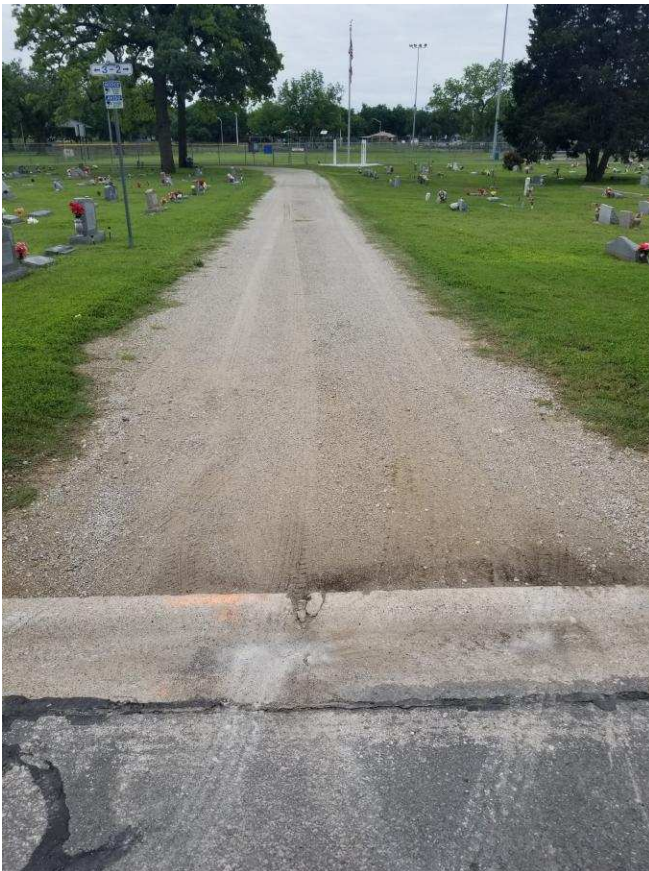
Barrier: 5

2010 ADAS Section: 303.4

The walkway contains changes in level greater than a 1/2 inch high that should be ramped.

Level 4 (High): Parking and exterior accessible routes (DOJ Level 1) – moderately out of compliance

Provide a ramp from the street to the path of travel.

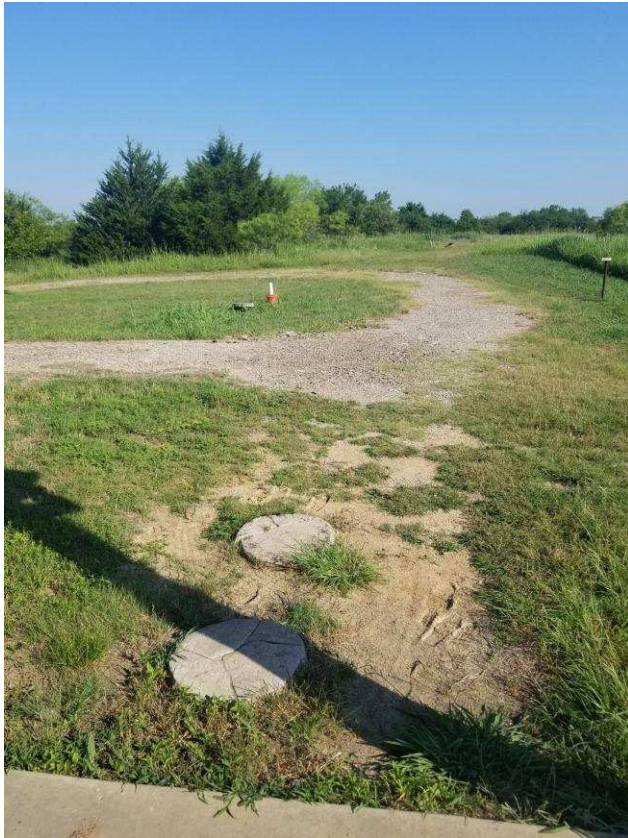
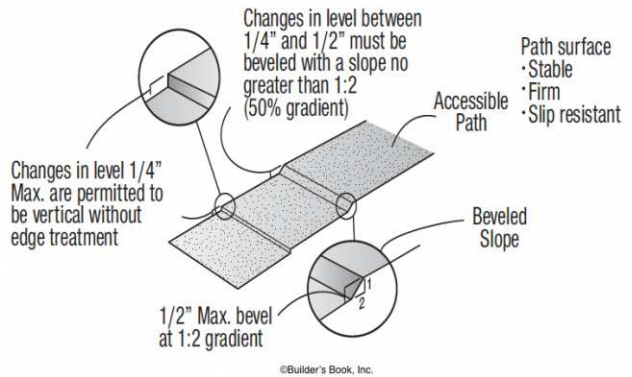
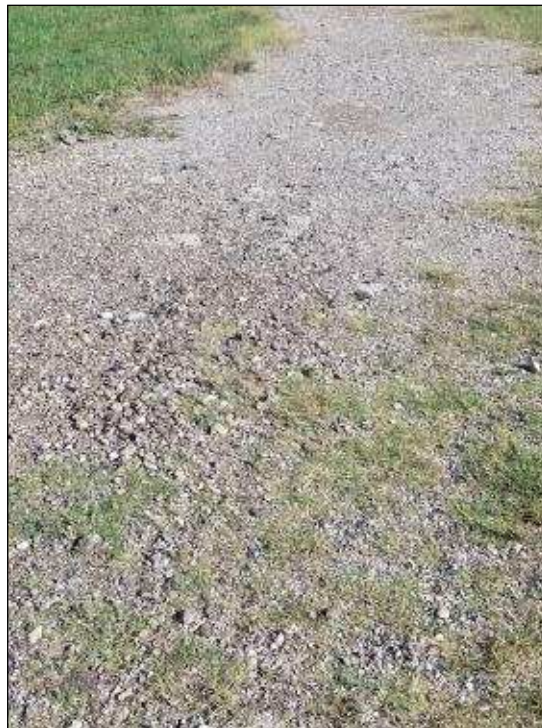
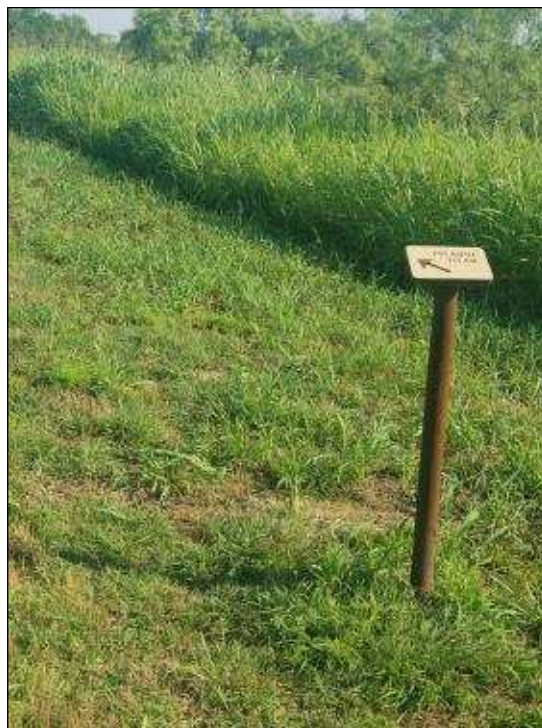
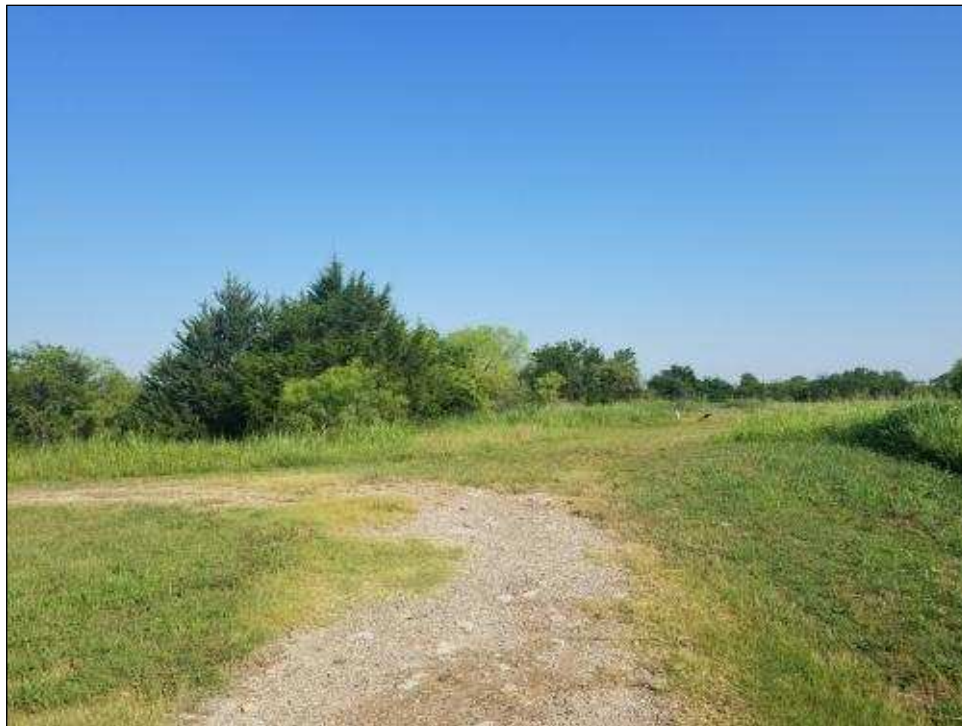
Barrier: 1

2010 ADAS Section: 302.1

The trail contains loose gravel that does not provide for a stable, firm, slip-resistant surface.

Level 4 (High): Parking and exterior accessible routes (DOJ Level 1) – moderately out of compliance

Provide a level, stable, slip-resistant ground surface as the path of travel to the trail head.

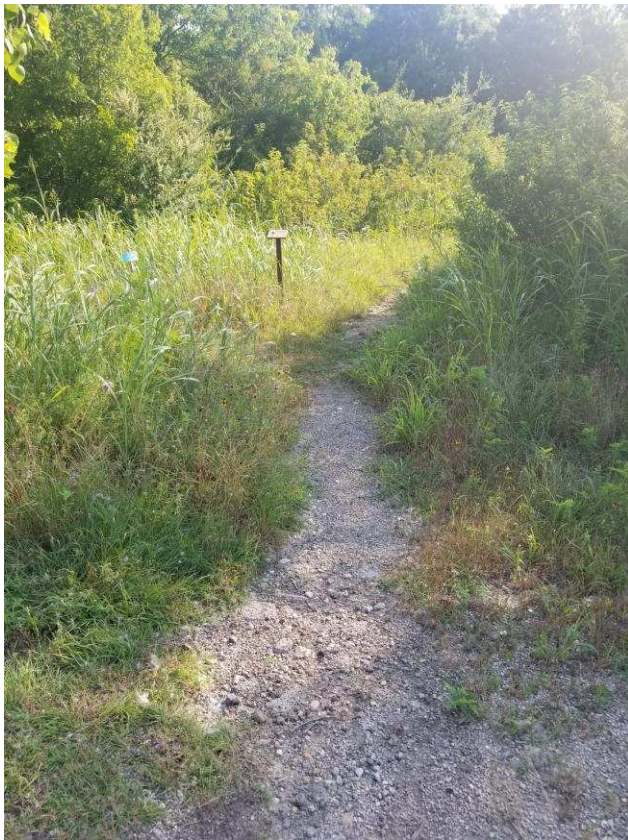
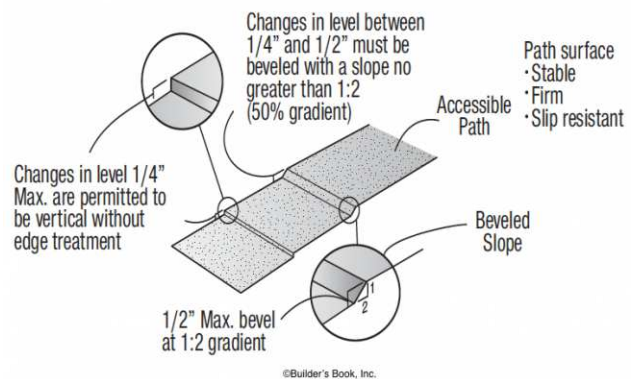
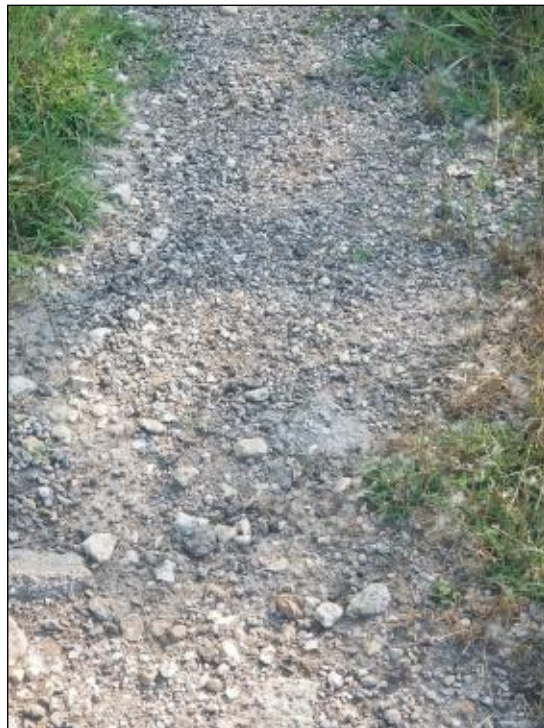
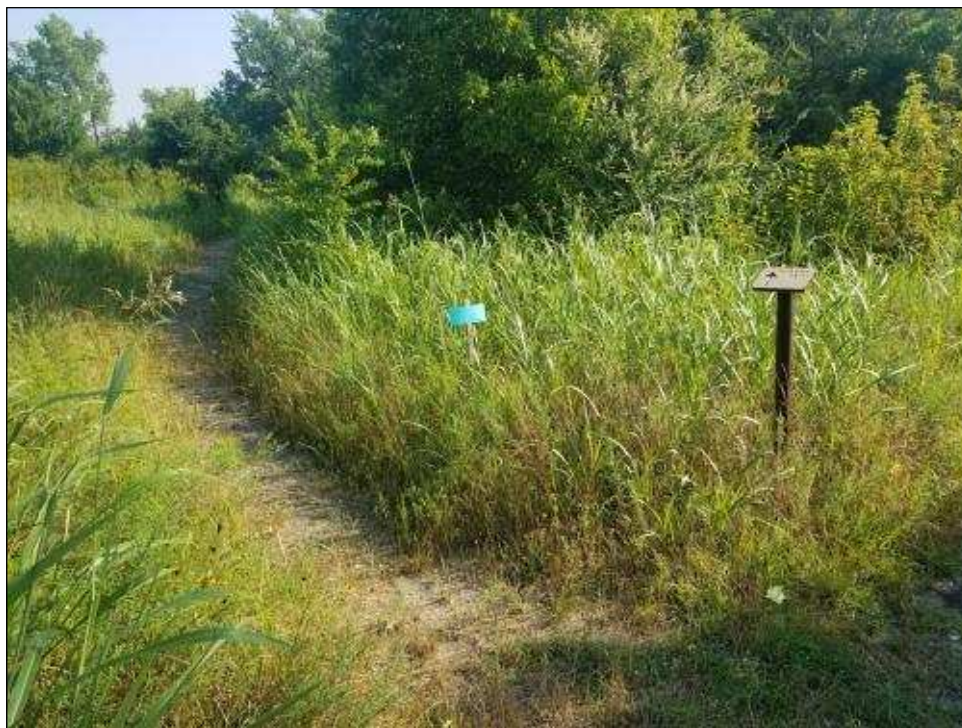
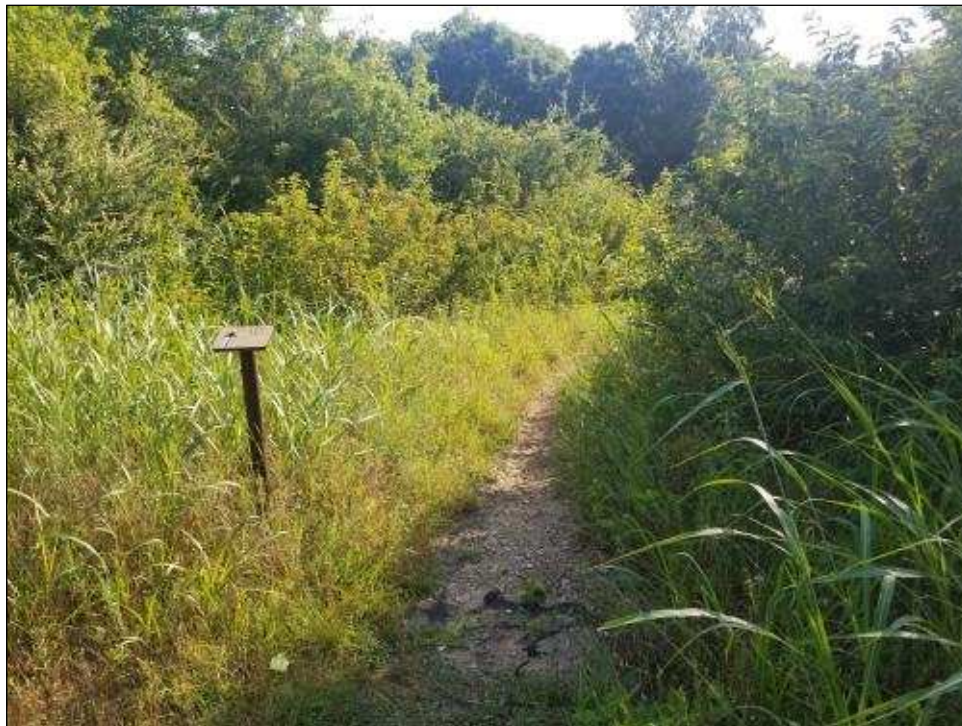
Barrier: 2

2010 ADAS Section: 302.1

The trail contains loose gravel that does not provide for a stable, firm, slip-resistant surface.

Level 4 (High): Parking and exterior accessible routes (DOJ Level 1) – moderately out of compliance

Provide a level, stable, slip-resistant ground surface as the path of travel to the trail head.

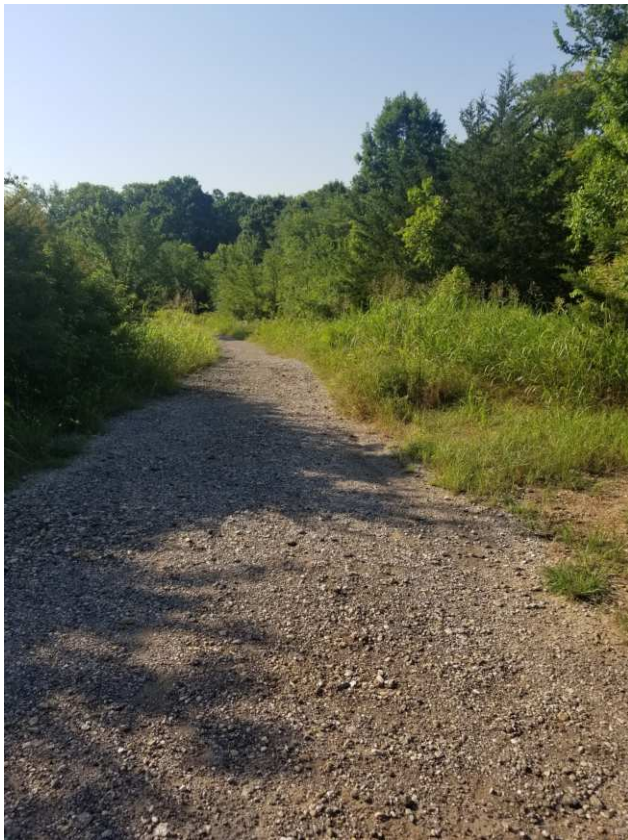
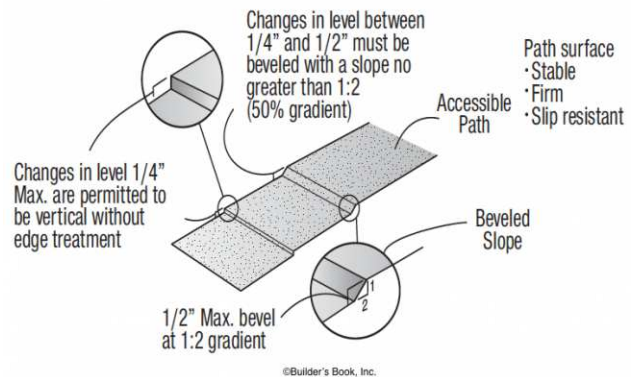
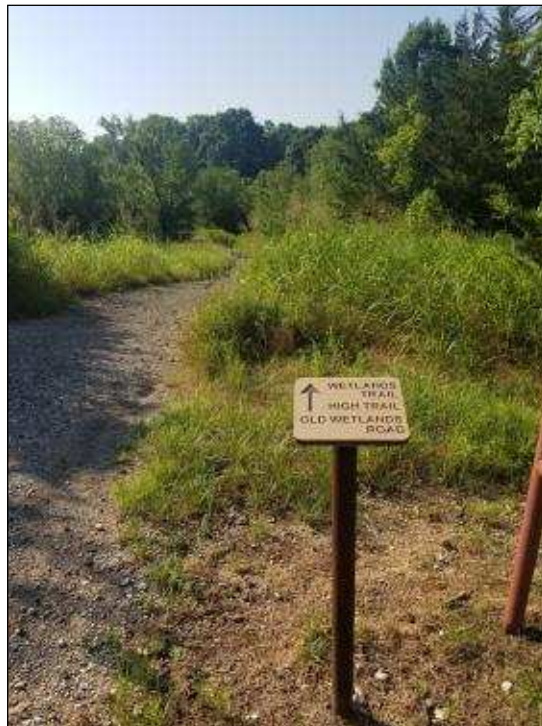
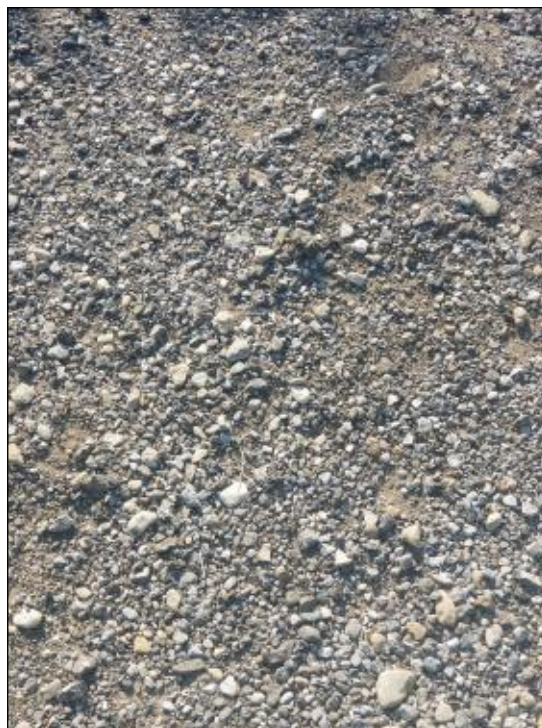
Barrier: 3

2010 ADAS Section: 302.1

The trail contains loose gravel that does not provide for a stable, firm, slip-resistant surface.

Level 4 (High): Parking and exterior accessible routes (DOJ Level 1) – moderately out of compliance

Provide a level, stable, slip-resistant ground surface as the path of travel to the trail head.

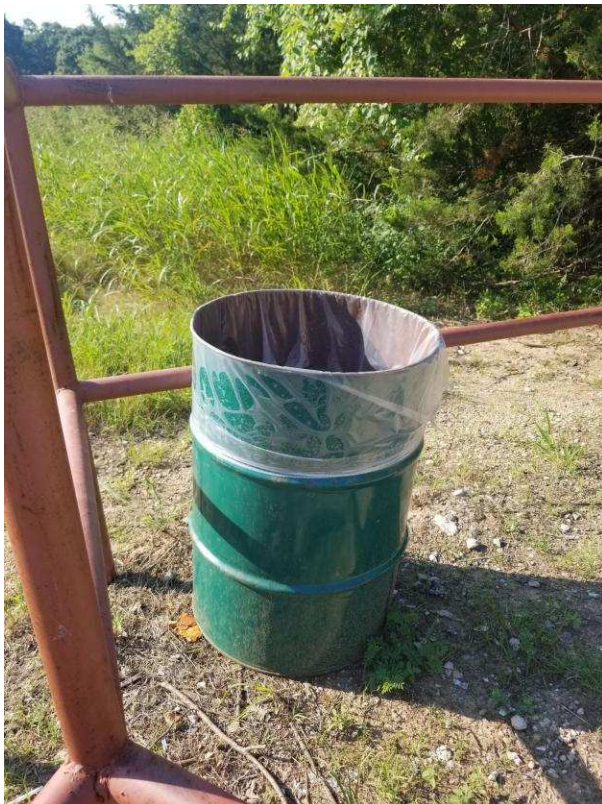
Barrier: 4

2010 ADAS Section: 206.2.2

There is no accessible route
to the trash can.

Level 7 (Medium): Access to goods and services (DOJ Level 2) – minimally out of compliance

Relocate trash can closer to an accessible path of travel.

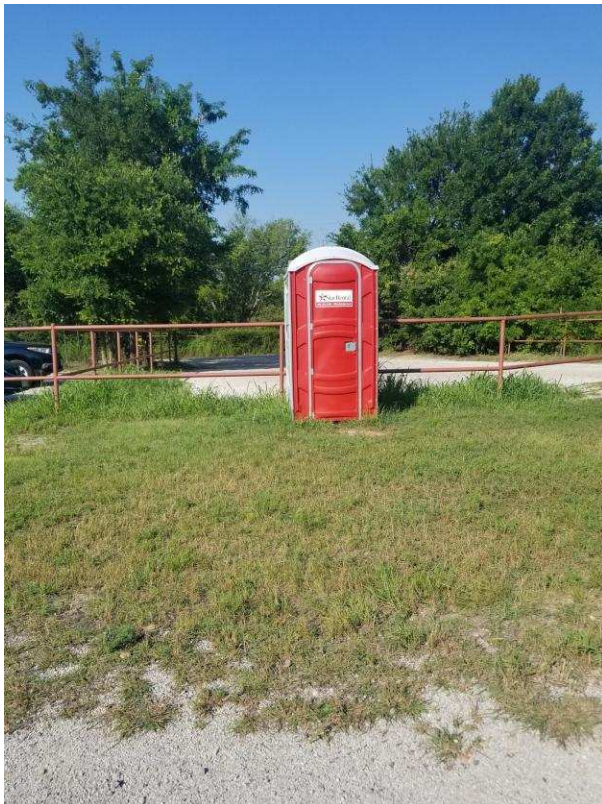
Barrier: 5

2010 ADAS Section: 213.1

The portable public
restroom is not compliant.

Level 6 (Medium): Parking or exterior accessible routes (DOJ Level 1) – minimally out of compliance
Access to goods and services (DOJ Level 2) – moderately out of compliance
Restrooms (DOJ Level 3) – severely out of compliance

Provide an accessible portable restroom with an accessible path of travel.

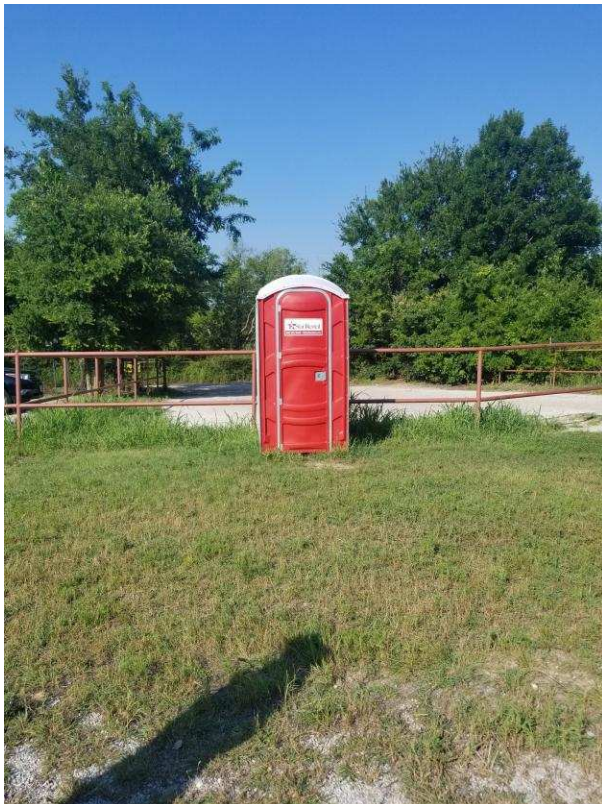
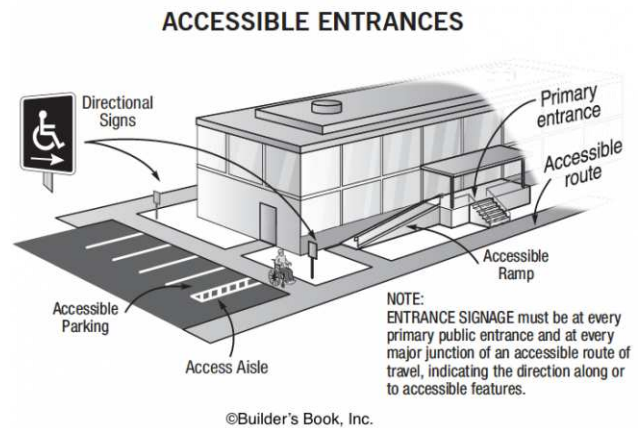
Barrier: 6

2010 ADAS Section: 206.2.2

There is no accessible route
to the portable restroom.

Level 6 (Medium): Parking or exterior accessible routes (DOJ Level 1) – minimally out of compliance

Provide an accessible route of travel to the portable restroom.

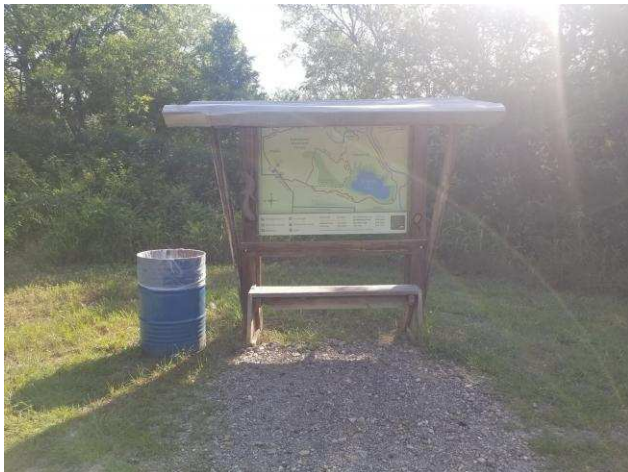
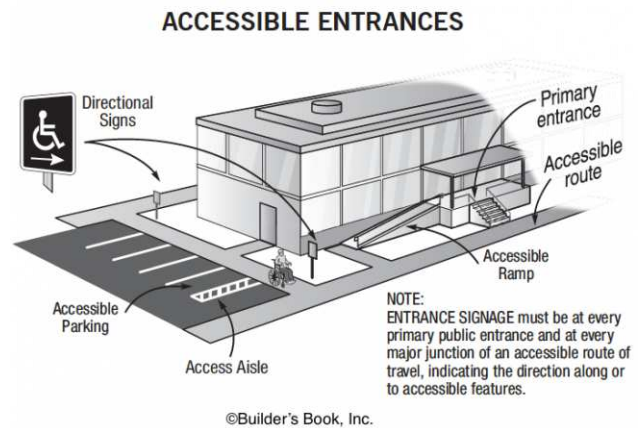
Barrier: 7

2010 ADAS Section: 206.2.2

There is no accessible route
to the trail maps.

Level 6 (Medium): Parking or exterior accessible routes (DOJ Level 1) – minimally out of compliance

Provide an accessible route of travel with a stable, firm, slip-resistant surface to the trail maps.
