FEASIBILITY STUDY

October, 2007

CITY OF DENTON DENTON SENIOR CENTER FEASIBILITY STUDY

BROWN REYNOLDS WATFORD

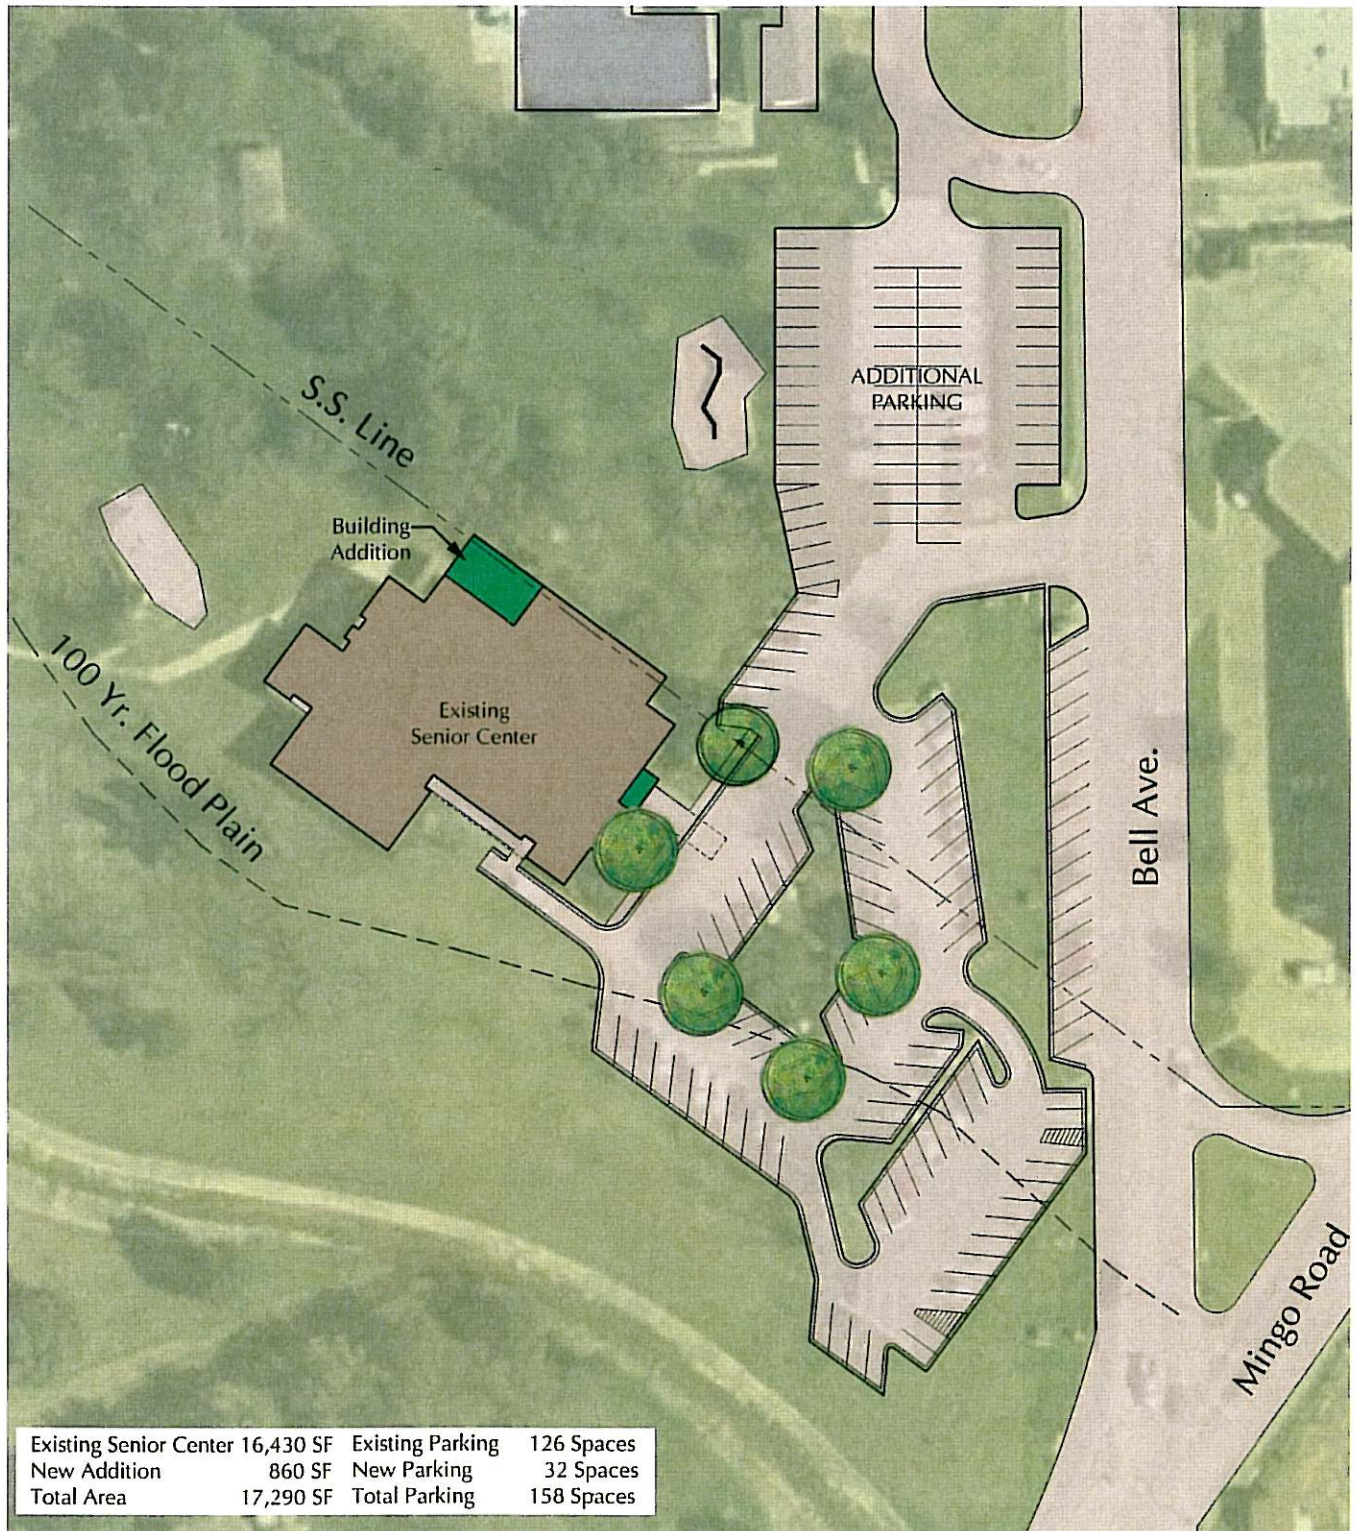
Study of Building Renovation
Option 1

After studying these programmatic needs and comparing them to the existing spaces, it is apparent that portions of the facility are not ideally used. While certain spaces such as the large Multi-Purpose rooms are heavily used through-out the day, other spaces are only used by a small portion of attendees for a few hours per day. The most underutilized spaces include the pool (billiards) area, the domino room, and the wood shop. While these activities may actually deserve their own rooms, the limited area of the existing senior center and high demand for fitness areas, requires the maximum multi-use of spaces. As a solution, the following conceptual senior center renovation and expansion design combines one pool table with a new Lounge that has comfortable furniture

and a self-serve coffee bar. It also converts the existing domino area into a Fitness Room and combines domino and card playing into a new Game Room in a building addition where the existing library is located. The existing front card playing room is converted into a Library / Reading Room. And finally, if the Woodshop could be relocated off site, the existing space would make an ideal Activity / Media Room for additional game playing space or have the capability for a TV lounge or larger movie / lecture gatherings. Although this renovation expansion may not solve long-term needs, it would give patrons a new sense of ownership and pride in their home away from home, while future planning continues.

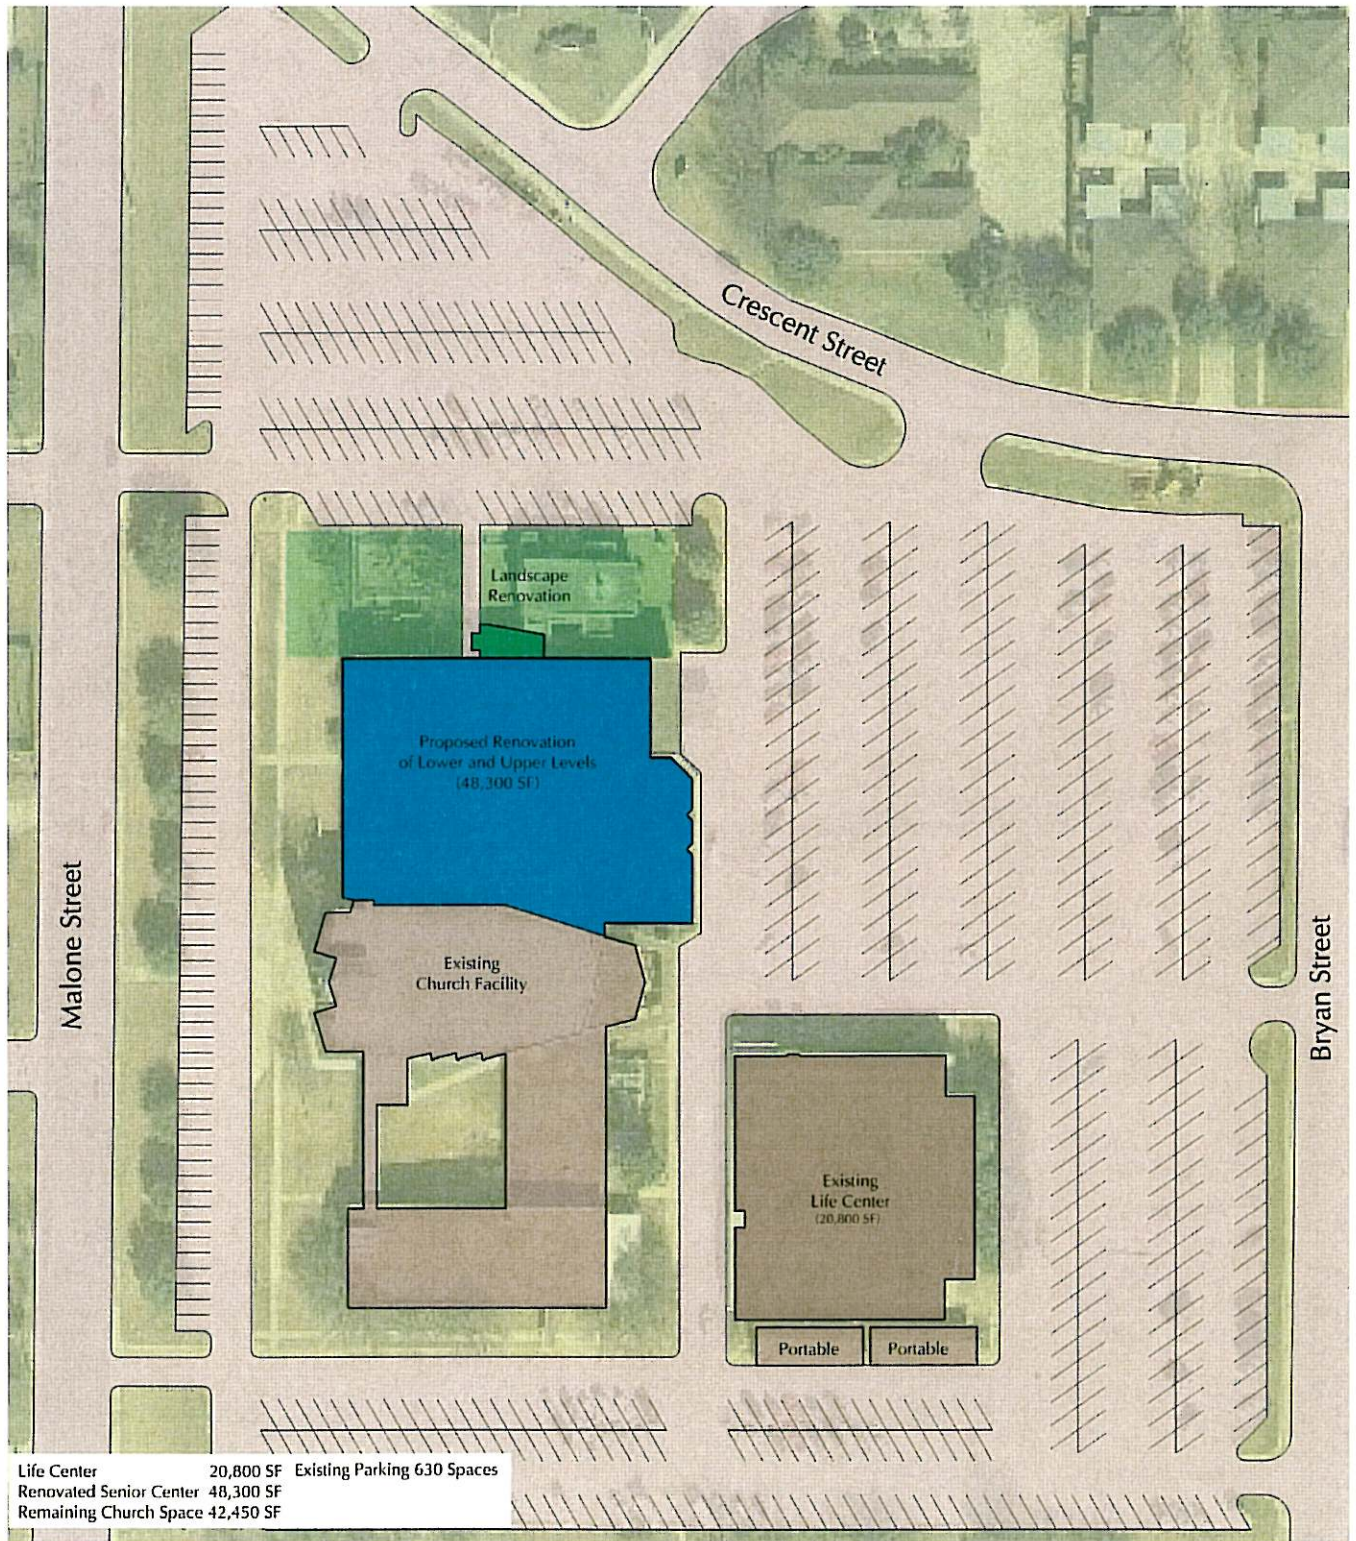
The following two floor plans show a two phase approach for construction. Phase 1 would renovate the first floor and provide 29,000 square feet. Phase 2 would renovate the second floor and provide an additional 19,000 square feet for a total building area of 48,000 square feet.

Life Center 20,800 SF Existing Parking 630 Spaces
 Renovated Senior Center 48,300 SF
 Remaining Church Space 42,450 SF

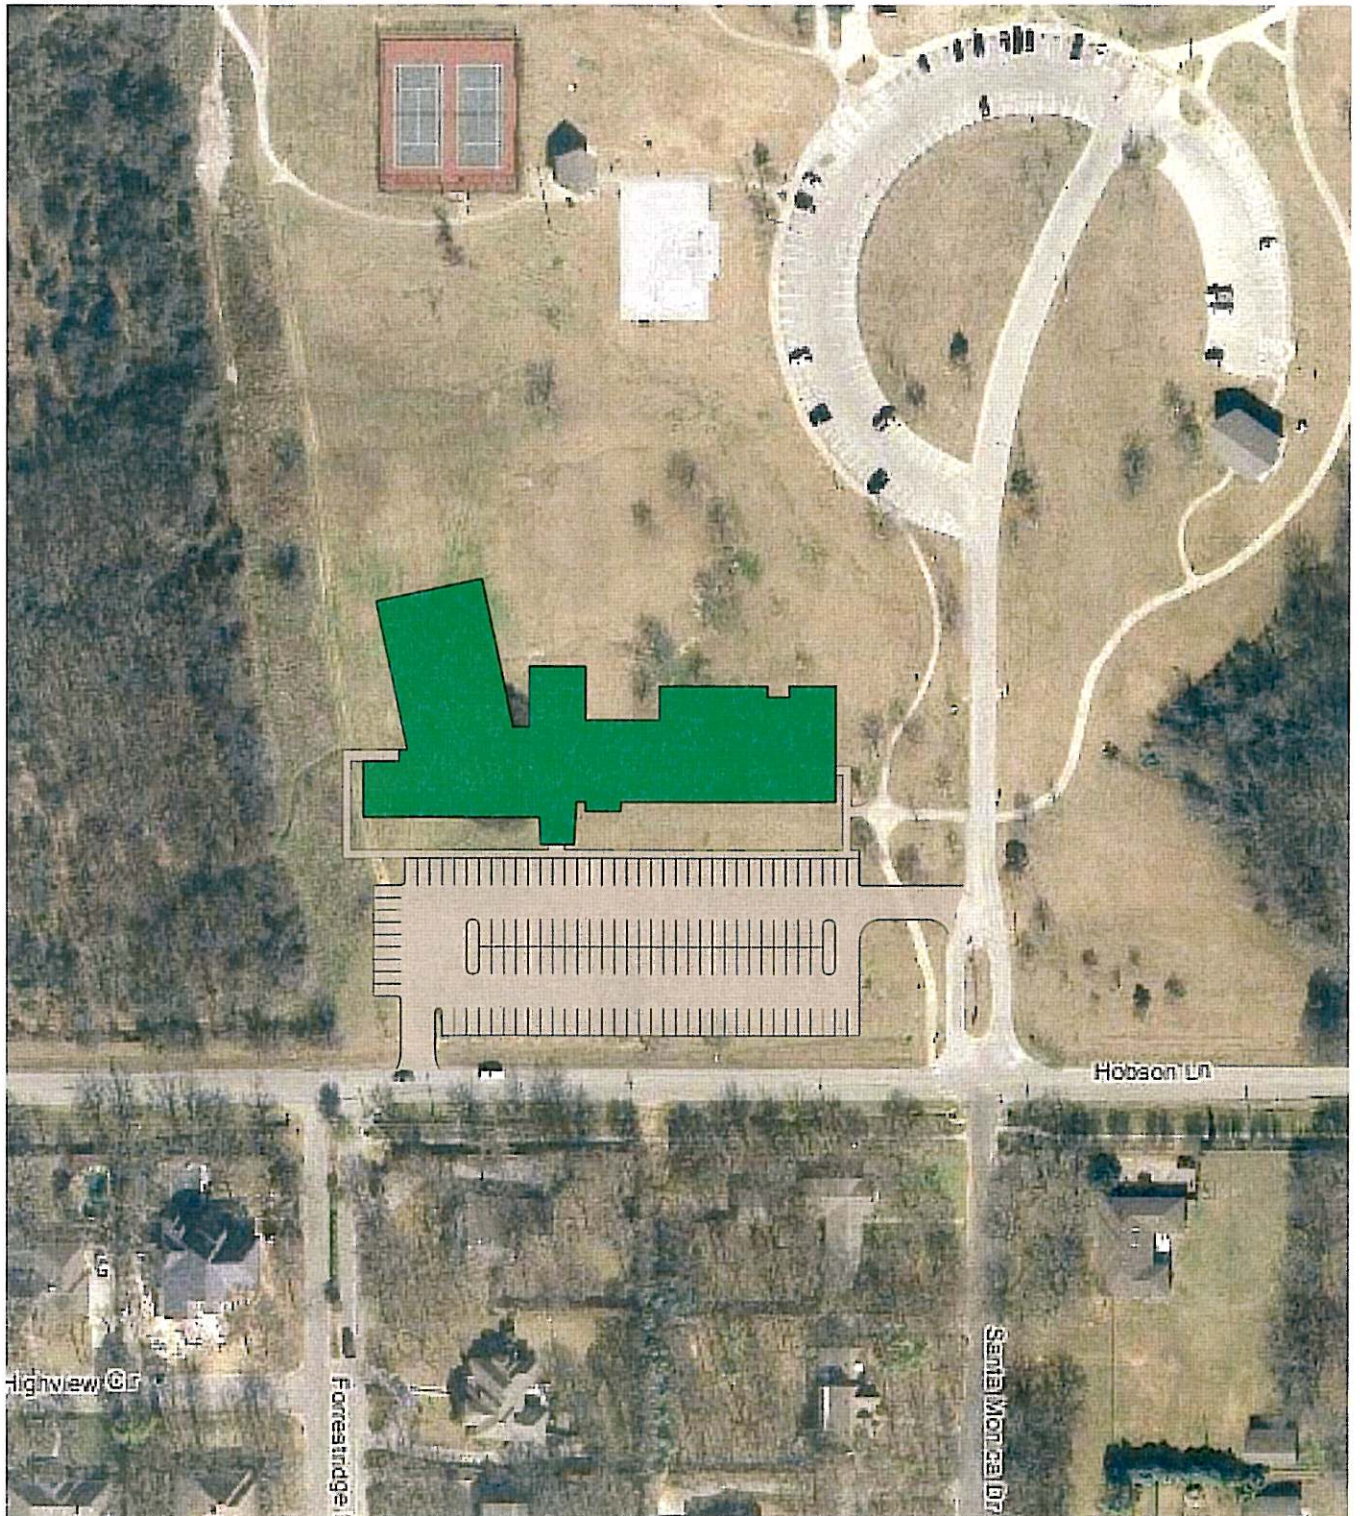
Site Study South Lakes Park

SITE PLAN
NOT TO SCALE

Following the renderings, site plans of the new senior center, along with approximately 135 cars, are shown in four city parks selected by the Park Department in order to study the its scale and impact on the existing park amenities. The four parks are Mack Park, Lake Forest Park, North Lakes Park, and South Lakes Park. The parks were not selected to align with locations of Denton's senior populations, but simply as "fit" studies in city owned property. The next step beyond this study is a demographic study to investigate current and future numbers and concentrations of senior populations. This information will inform potential project locations and verify the appropriate scale facility. The demographic study should also run parallel with dialogue with senior center participants about their preferred project location and options for transportation.

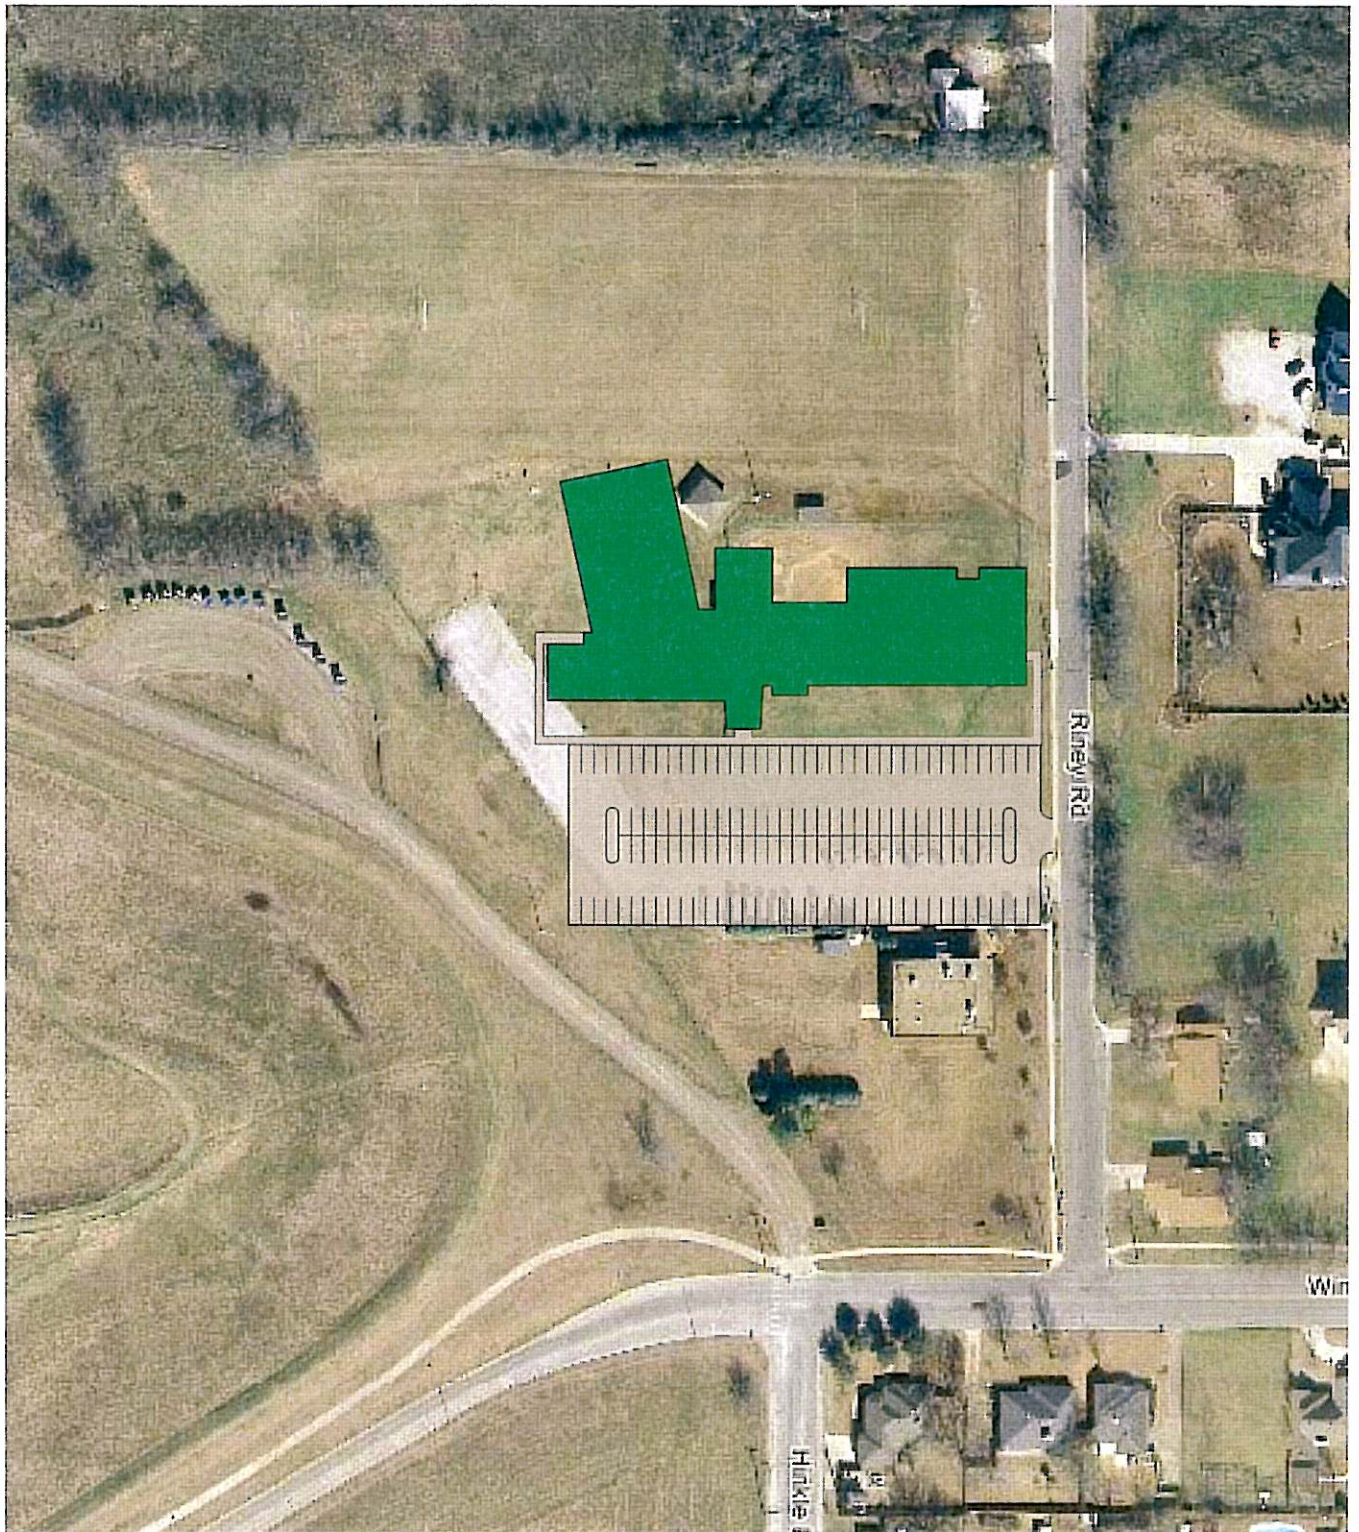
Site Study North Lakes Park

SITE PLAN
NOT TO SCALE

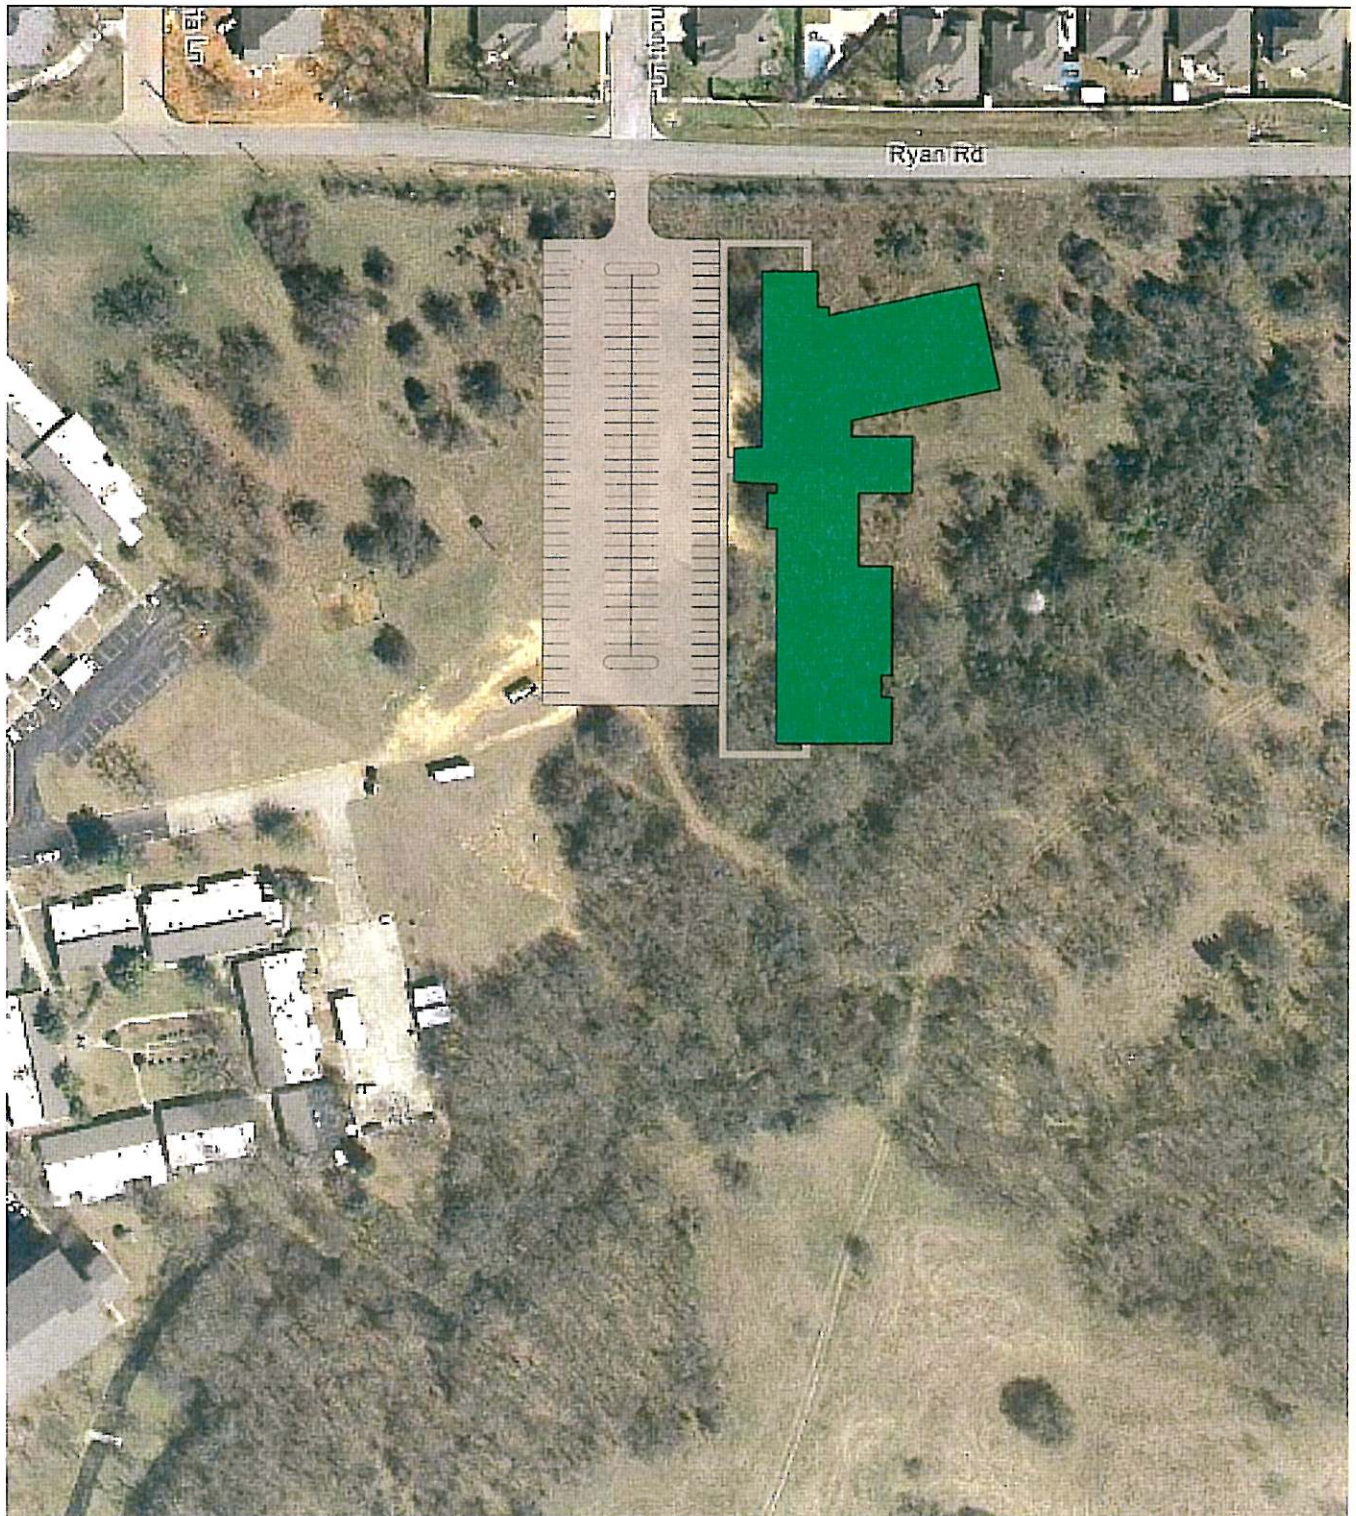
Site Study Lake Forest Park

SITE PLAN
NOT TO SCALE

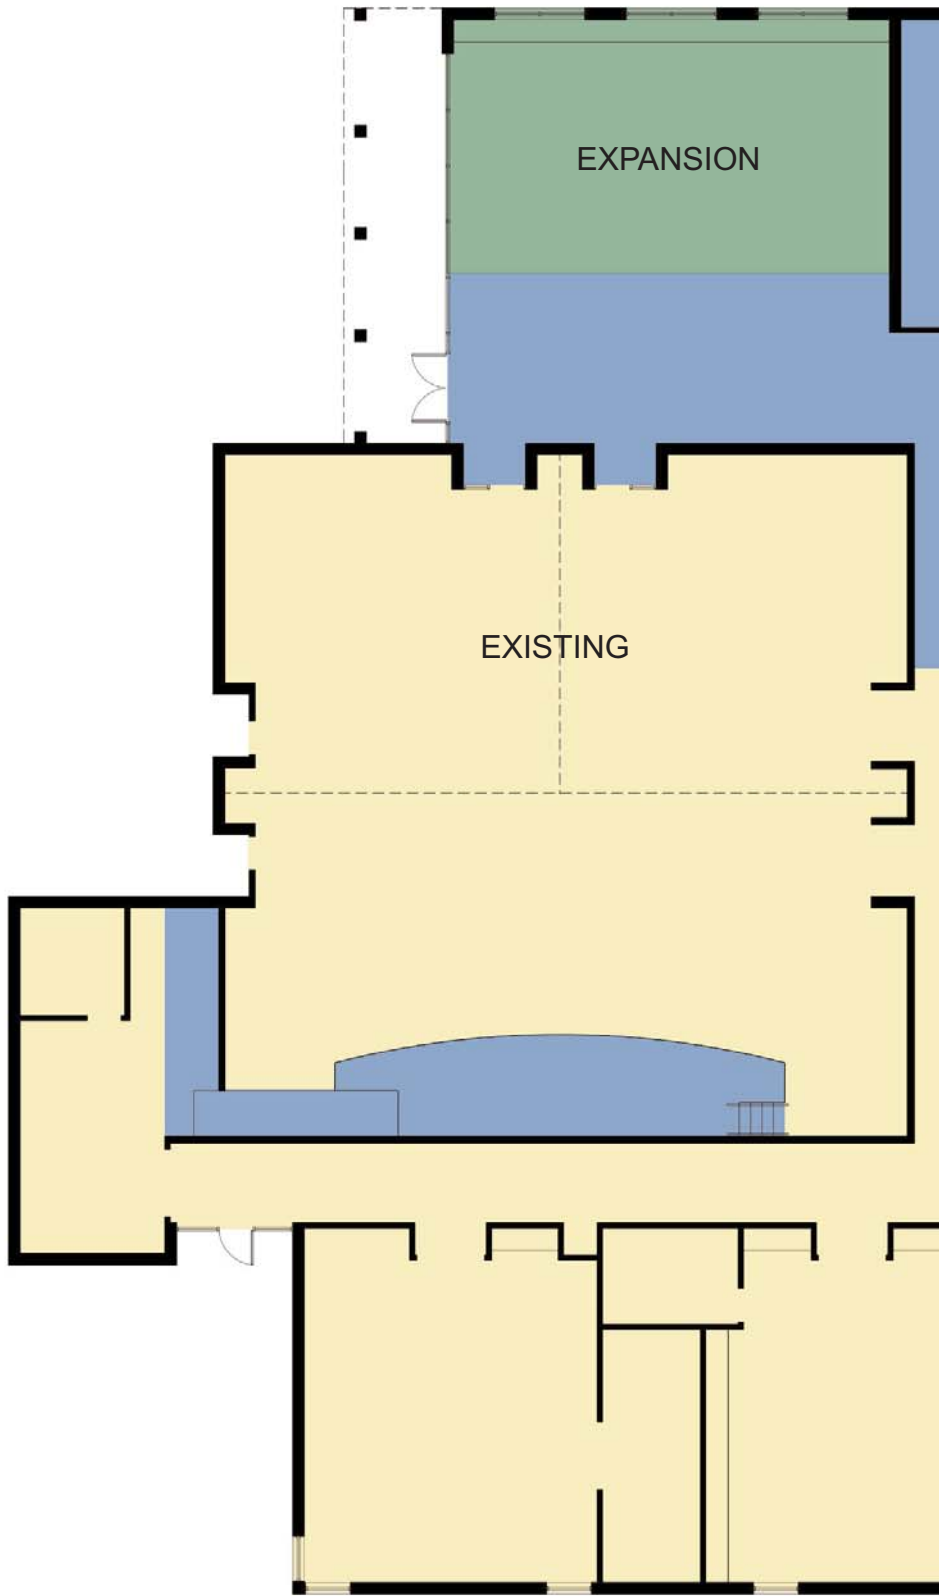
EXISTING SANITARY SEWER LINE

RENOVATION

EXPANSION

EXISTING

Senior Center Addition Possibility Required Sewer Line re-route if building addition constructed

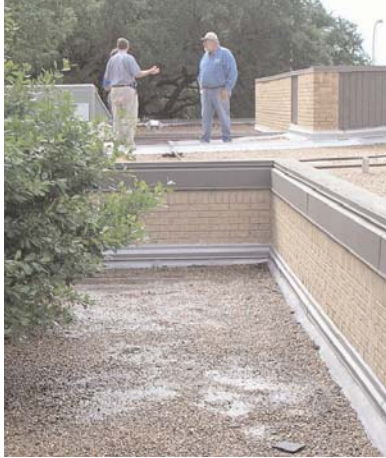
Roof Condition

The Senior Center roof has seven sections separated by parapets and curbs with at least four different elevations. Overall the roof is in excellent condition and well maintained by City staff. The current roof is a modified bitumen membrane that was installed in 1989. The membrane surface, parapet copings and flashings appear in good to excellent condition. City staff provides required maintenance and also works with a roofing consultant, Aramko. The higher portions of the roof generally drain to the lower section via scuppers and downspouts. The lower roof areas have roof drains and piping internal to the building. The only drainage issues noticed were leaves collected along the parapets and standing water on the raised roof section over the Domino Hall and Game Area. It appears that the scuppers are too high for adequate drainage of this area onto the lower roof over the entry and Living Room. One code issue is that condensate from the mechanical roof-top units drain into the roof drains and storm sewer, in lieu of the sanitary sewer.

This roof should be adequate to last another 10 to 15 years with proper maintenance. A building renovation and expansion should only require roof work associated with mechanical and plumbing renovations should as roof curbs and plumbing vents. The building expansion roof membrane should match the existing roof for ease of maintenance.

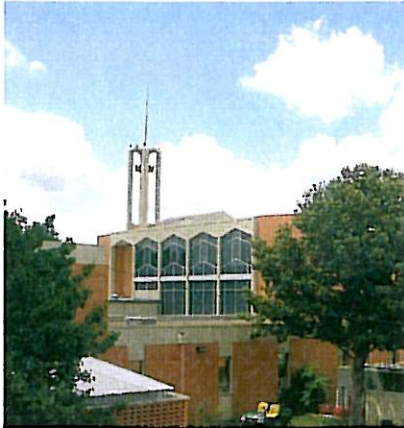
The west addition which in-filled the courtyard was a two story steel structure. The roof system consist of an intermediate rib metal deck supported by open-web steel joist at five foot on centers and the floor system consists of a concrete slab over non-composite steel form deck supported by open web steel joists at two foot on centers. The roof and floor joists are supported by steel wide flange beams which are supported by steel columns to the foundation.
